Elite Home Inspections
Confidential - Property Inspection Report - Confidential

7444 Sample Street, Boardman, OH 44512

Inspection prepared for: John Doe

Date of Inspection: 3/1/2016

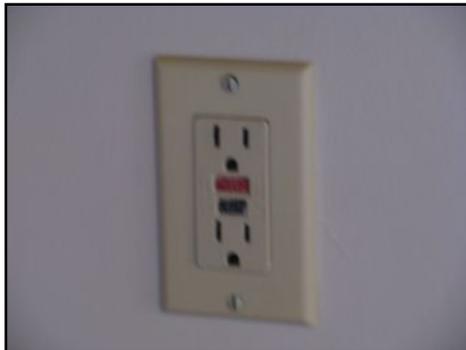
Left side of Sink

SAFETY CONCERN: A GFCI failed the trip test. This needs to be corrected, it is a safety issue that may result in an electrical shock or electrocution. Recommend further evaluation and correction by a licensed electrician.

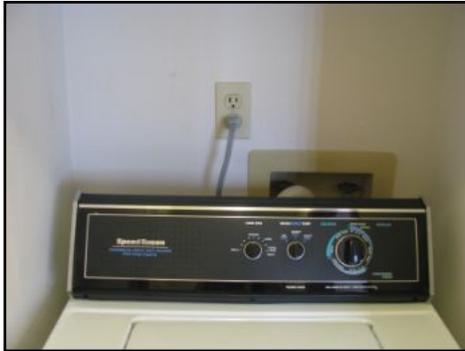
SAFETY CONCERN: I did not observe GFCI protection at the laundry area. This needs to be corrected, it is a safety issue that may result in an electrical shock or electrocution. Recommend a licensed electrician provide an estimate on installing GFCI protection and perform the installation.

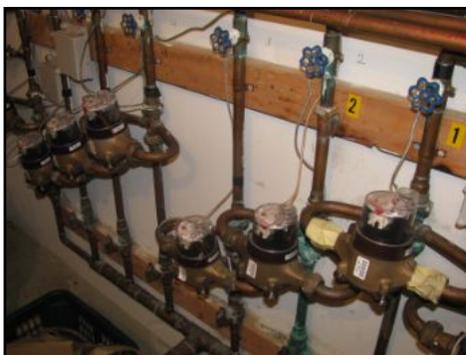
A gate valves was observed at one or more locations. This type of valve has a history of leaking at the stem seal with age. Recommend monitoring for leaks and budgeting for an upgrading to ball type valves. If leaking is observed it needs to be repaired to prevent water intrusion which can cause damage to the interior and potentially encouraging the growth of microbes such as mold fungi. Recommend correction by a licensed plumber.

Corrosion was observed at the shutoff valves which may start leaking at any time. This should be repaired to prevent water intrusion which can damage materials, cause rot and decay and encourage the growth of microbes such as mold fungi. Recommend correction by a licensed plumber.

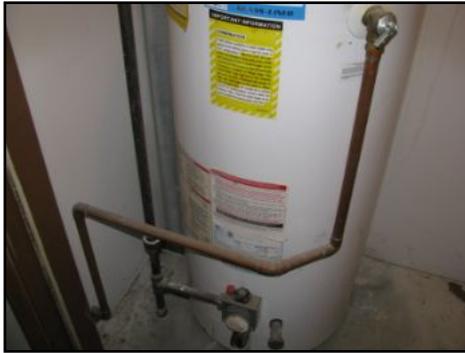
The discharge tube is copper.

The **TPR Valve** discharge pipe should discharge to a termination point that is readily observable by the building occupants. This could be a potential safety issue if the occupants were unable to observe water discharging which may indicate a problem with the TPR valve. Recommend correction by a licensed plumber.
